# **DURABILITY OF PRECAST PRESTRESSED CONCRETE PILES IN MARINE ENVIRONMENTS**

A Dissertation  
Presented to  
The Academic Faculty

In Partial Fulfillment  
of the Requirements for the Degree  
Doctor of Philosophy in the  
School of Civil & Environmental Engineering

Georgia Institute of Technology

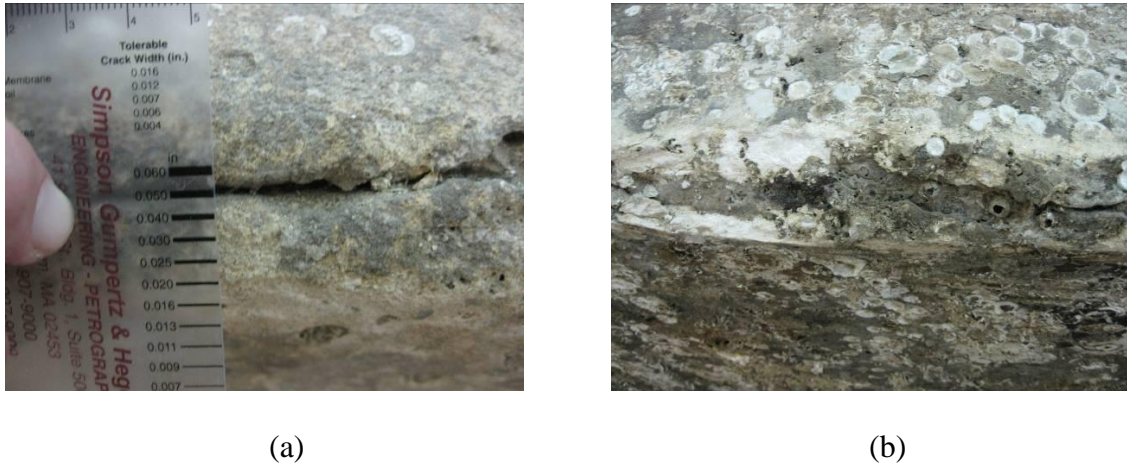
Figure 3.20: (a) Cracking along corner of pile, and (b) marine growth in crack

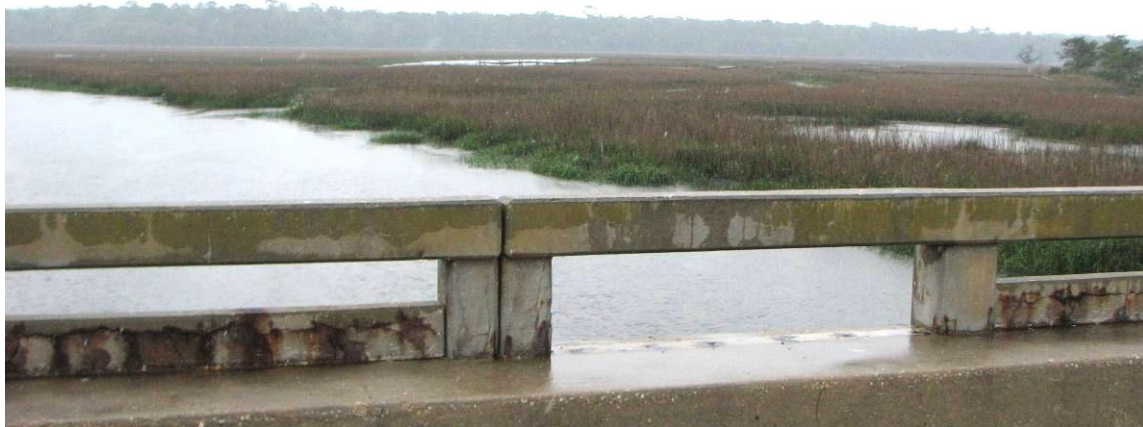
Figure A.3: Corrosion damage in cast-in-place Barrier of Harriett's Bluff Road at Deep Creek Bridge (Bridge No. 039-0049)

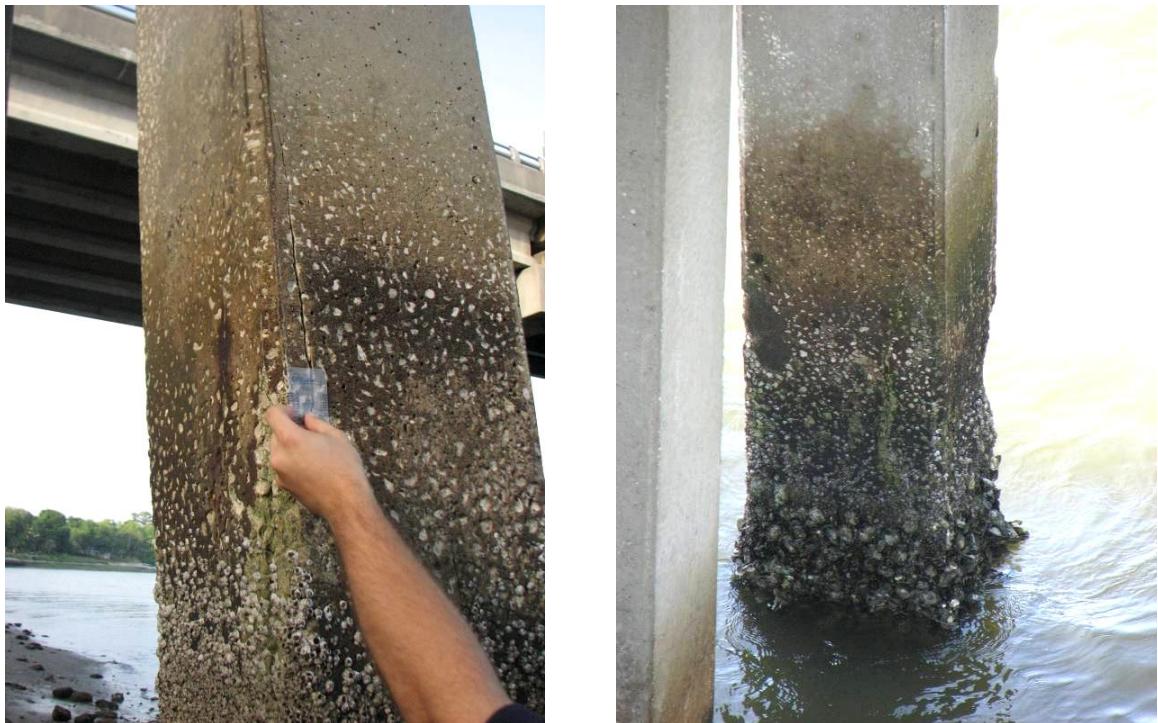
Figure A.15: Severe damage to concrete piling on Island Expressway at Wilmington River Bridge (Bridge No. 051-0132)

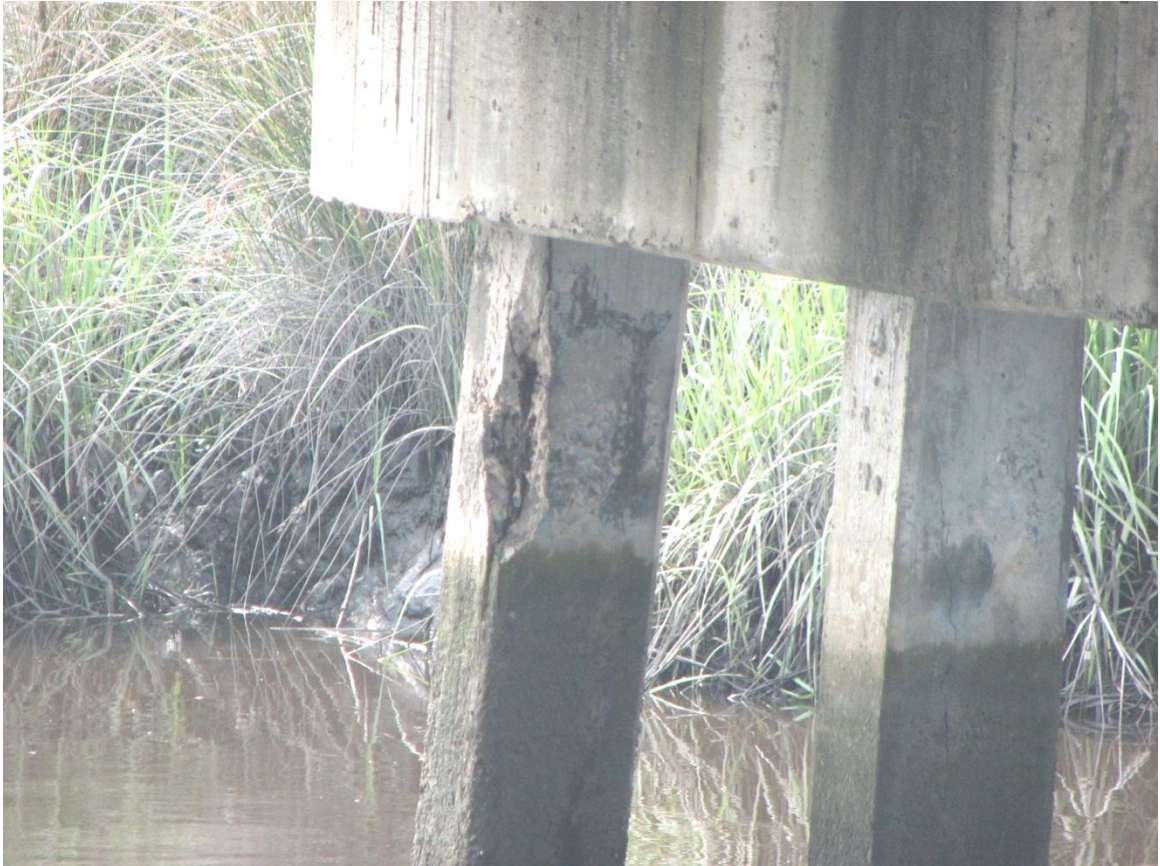
Figure A.27: Deterioration of precast concrete piles in substructure of Ocean Highway at Riceboro Creek Bridge (Bridge No. 179-0005)

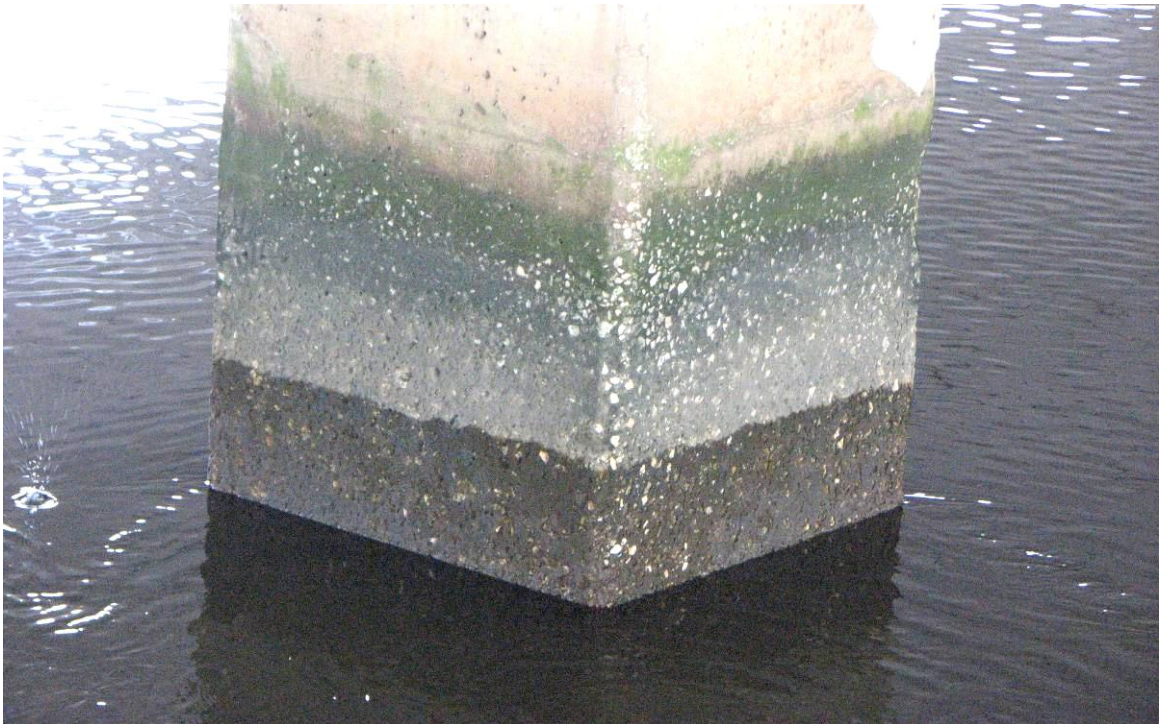
Figure A.30: Typical surface abrasion of concrete on Ocean Highway at Champney's River Bridge (Bridge No. 191-0005)

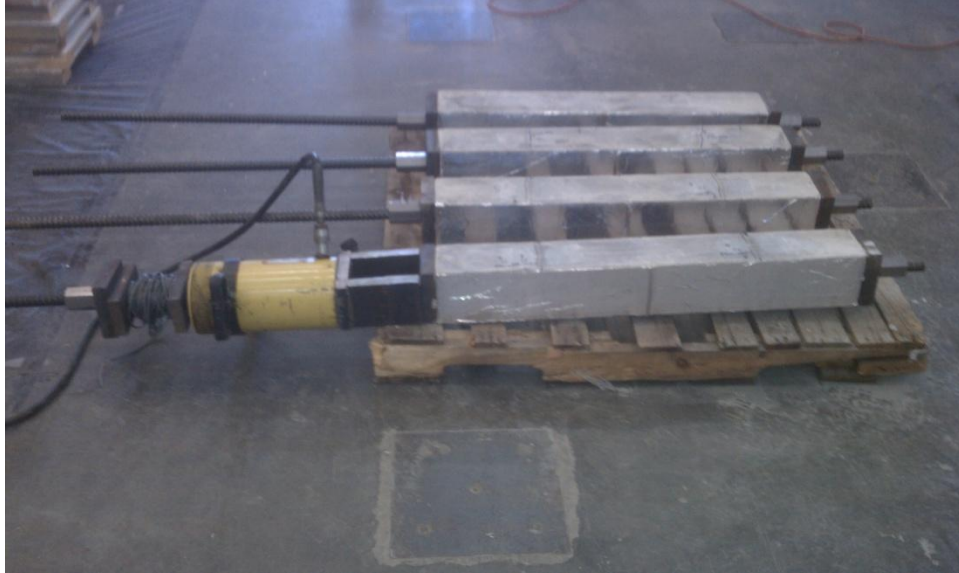
Figure F.1: Post-tensioning of specimens

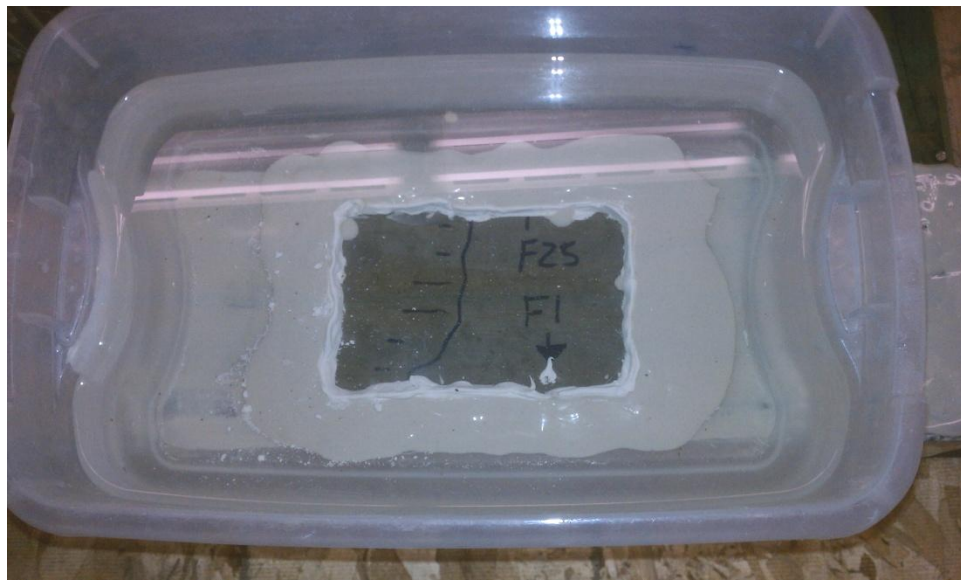
Figure F.6: Exposure surface inside of ponding container with simulated seawater solution
